Case Study Results:

| Case Study: Reynolds | | | |
| Location: Crieve Hall, TN 37220 | | | |
| House Style / Size: Ranch / 1,400 SF | | | |

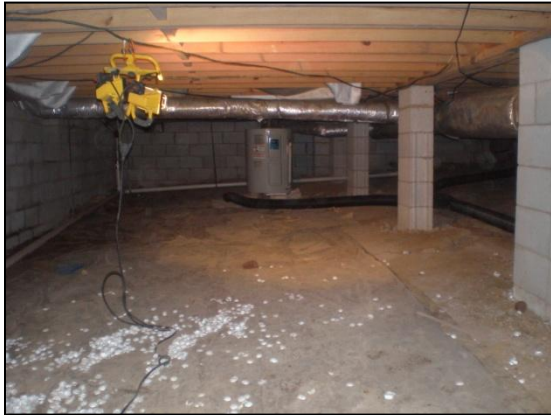
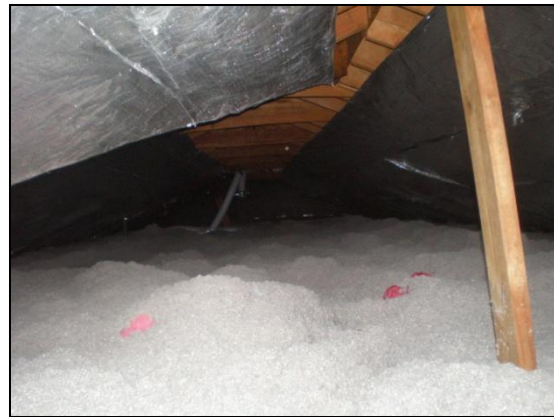
Before:

Crawl Space

- Crawl Space – E3 installed a 3 ply 12-mil *Griffolyn* brand vapor barrier in the crawl spaces to control moisture levels and suppress harmful gases like Radon from entering the living space. E3 laid plastic piping underneath the vapor barrier in case radon venting is needed in the future.

- Rim & Band / Crawl Space Walls – The rim band (area between basement and first floor) is one of the most problematic areas for air leakage and heat/cold intrusion. E3 used *BioBased* 0.5 lb open cell polyurethane spray foam to seal and insulate the rim band around the perimeter of the house as well as the exterior crawl space walls, creating a sealed crawl space system.
