CHASING Radon

by Lesley Herrmann

In a previous article entitled “Solving the Unintended Consequences of a Home Performance Renovation”, (HE Winter '18, p. 12) I discussed the work that my company, E3 INNOVATE, did on a remodeled home in Nashville, Tennessee to fix the home performance issues that arose from a poorly executed sealed crawl space system. The homeowners initially called in E3 after their renovation because of concerns with odors and high radon levels.

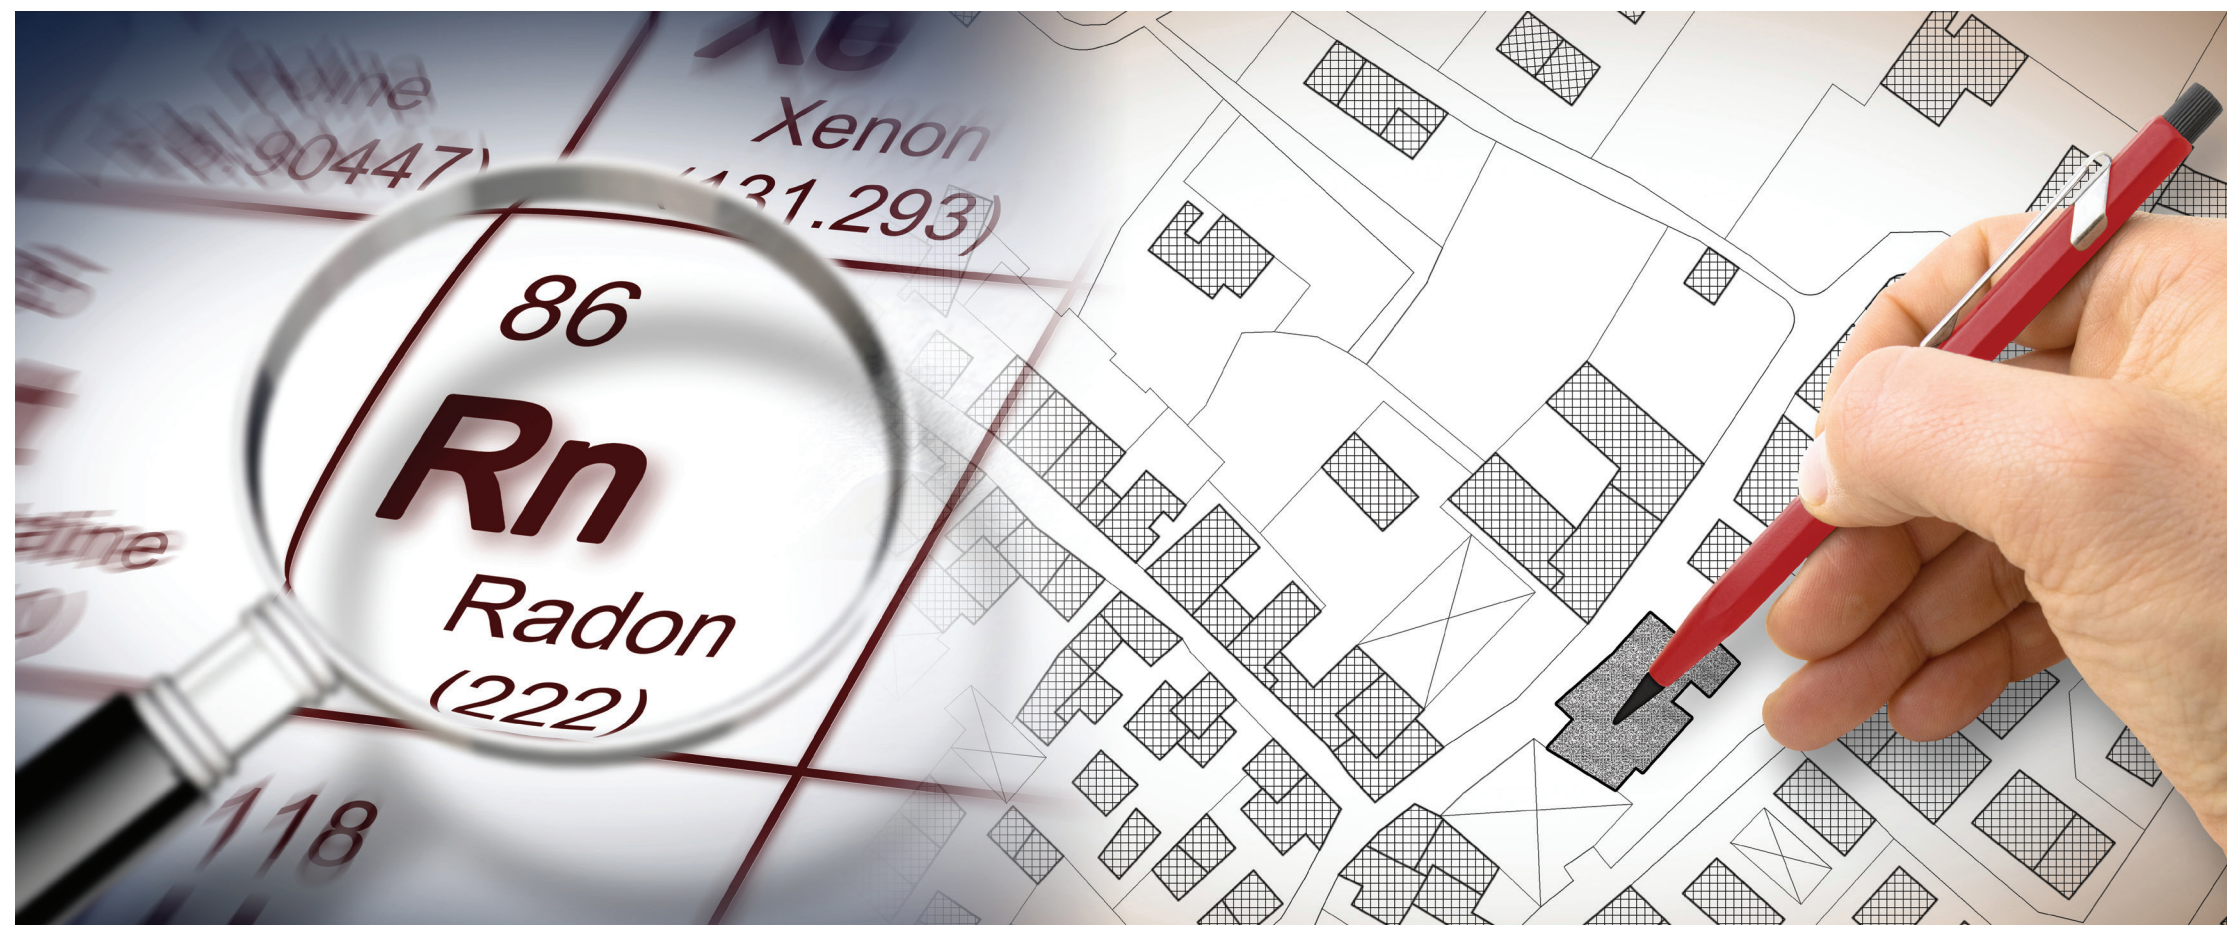
The radon system E3 installed included the use of an HP220 radon fan on the exterior of the home. The network of PVC and perforated piping spanned the majority of the footprint of the house (see Figure 1). Numerous gate valves and monometers

along the network of PVC piping allowed for the balancing of the system and provided greater control **overflow** rates. Because of the simultaneous need to address odors and radon, E3 utilized an energy recovery ventilator (ERV) to help flush the house with fresh air as well as to dilute radon. A radon control device, a “radostat,” installed in the master bedroom, continually monitored radon levels. When radon exceeded 4.0 pCi/l, the sensor would trigger the ERV to run at full capacity to help with dilution. Early data showed the rising radon levels would peak at 4 pCi/l and then fall once the ERV kicked on.

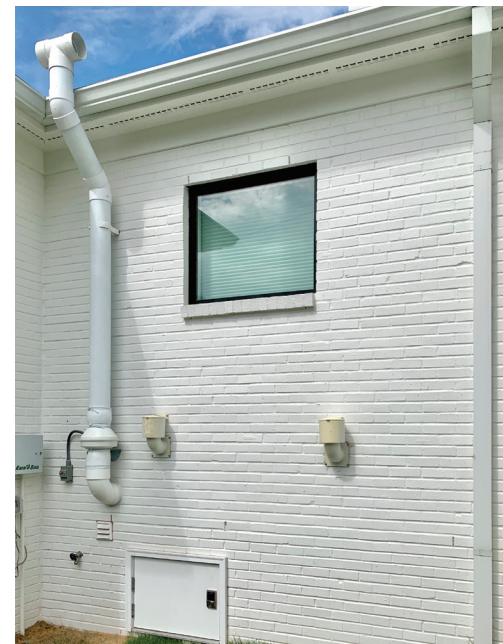
left An RN-4 radon fan with 6-inch piping serves as the primary outlet. right A secondary PH-220 radon fan with 4-inch piping serves as the secondary outlet and provides additional suction in the system.

E3 replaced the existing radon HP220 fan with a new RN4 fan, which is typically used only in commercial settings because of its high flow rate. The benefit of the RN4 is that it offers the ability to adjust fan speed, an important feature for balancing. The HP220 fan was moved to the opposite side of the house since that section of piping was furthest from the suction point.
