Solving Unintended Consequences of a Renovation

SOLVING UNINTENDED CONSEQUENCES HOME PERFORMANCE RENOVATION

by LESLEY HERRMANN

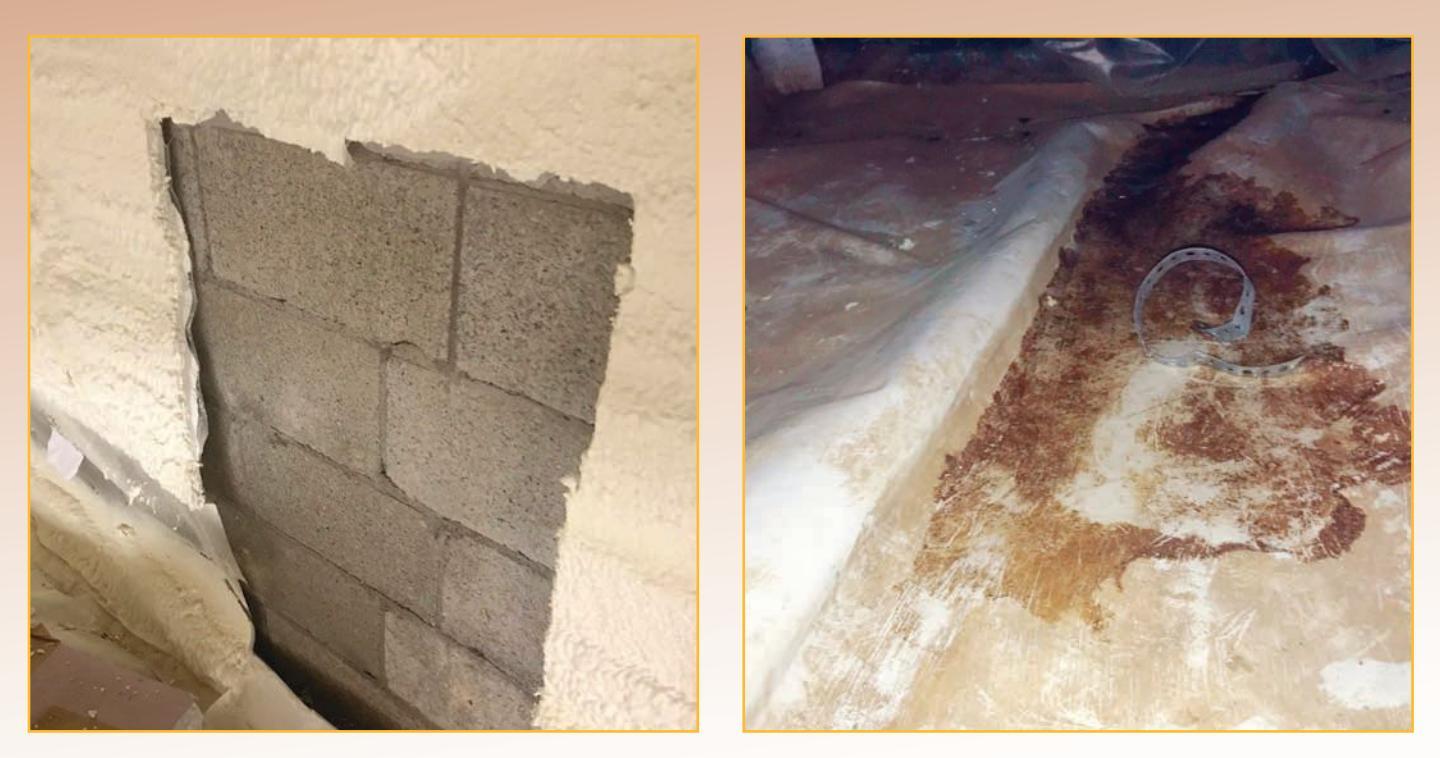
(left) A sample area was removed from the exterior wall to verify the thickness of foam and assess evidence of moisture. (right) Water pooling on laminate in the crawl space.

The crawl space encapsulation had been done incorrectly. Some areas had been left unsealed and others were underinsulated. Foam and laminate had been applied in a way that left large air gaps, preventing contact with the cement block walls. We observed signs of mold and mildew growth on the floor joists and on the laminate in the crawl space. We also found small puddles of standing water.

After removing the existing spray foam and laminate, we installed multibranched radon piping. Then we applied new water-blown, ultralow-VOC spray foam and new clean laminate to every compartment and cavity in the crawl space. To further protect against high humidity levels, we added a designated crawl space dehumidifier to keep air conditions within acceptable ranges, especially during the summer months. Duct leakage and penetrations were also sealed.

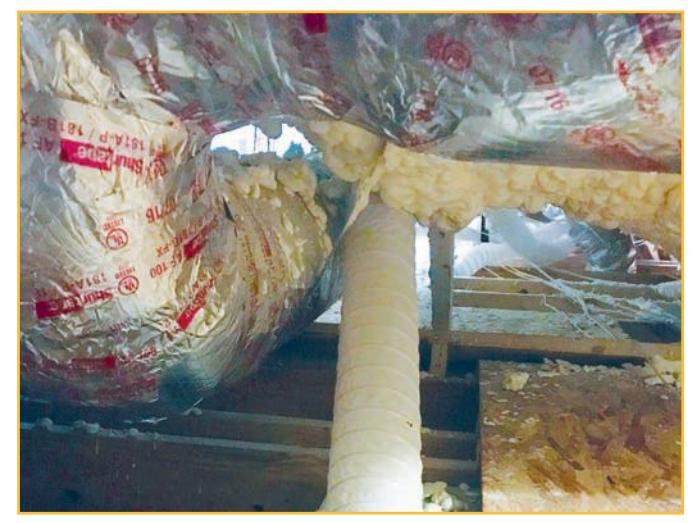
In the attic, there were a few thermal breaks in the spray foam that were causing stack effect problems and infiltration. We found crimping in the exhaust fan ductwork that was choking the airflow. We measured airflow rates of 10 and 30 CFM in two of the three bathrooms. (We like to see bathroom exhaust flow in the 50-60 CFM range.) We also found that the expensive motion sensors had been installed incorrectly, rendering the fan in the third bathroom nearly inoperable. The steam humidifiers were installed on the return side of the air handler unit (AHU), before the air filtration system and the AHU coil, rather than on the supply side. This arrangement creates perfect growing conditions for mold and mildew, which may then be distributed throughout the house.

Bathroom exhaust ducts had long runs, bends, and crimps, which choked air flow rates.

In the attic, the same water-blown spray foam was used to fill the gaps, helping to reduce the stack effect and minimize air moving upward through the house. In the bathrooms, new exhaust fans with hard piping and proper motion sensors were installed.

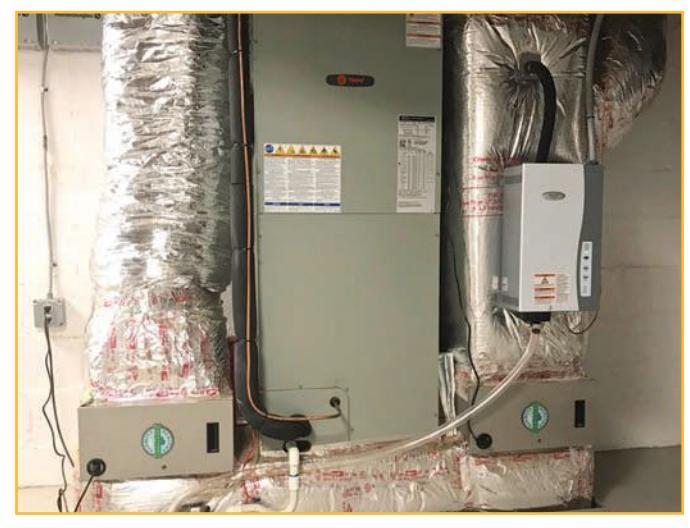
Whole-home humidifier installed on the return side of the air handler creates the potential for mold growth.

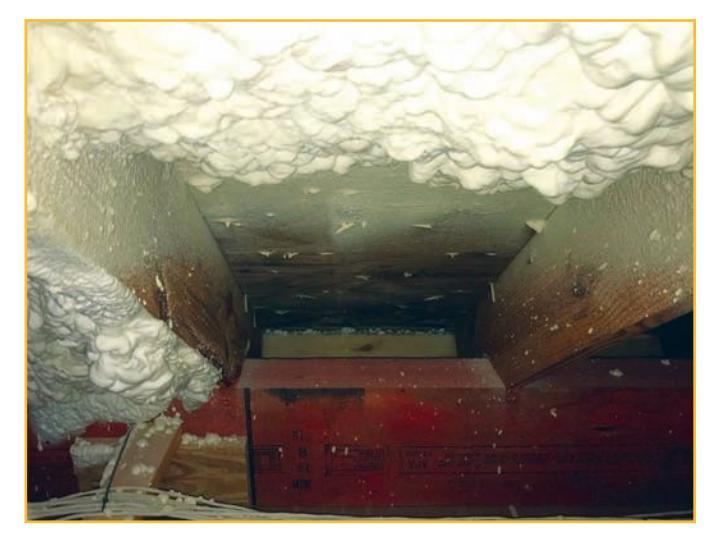
Spray foam gap in the attic creates leakage and increases the stack effect.

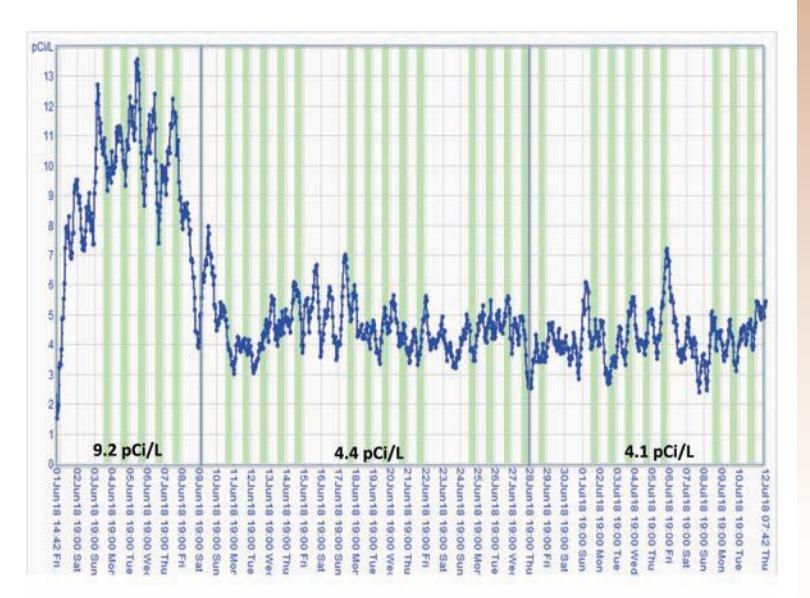
Figure 1. Digital radon devices monitor concentrations during the project and serve as a commissioning tool.

To address this, a Radostat was installed as a permanent ondemand radon mitigation solution. When indoor radon levels rise to 4 pCi/L or higher, the wall-mounted sensor signals the ERV to ramp up to Turbo mode to increase dilution. In this way, the device balances the need for more outdoor air with energy efficiency and comfort. After these adjustments, average radon levels in the master bedroom dropped significantly but were still above 4 pCi/L on average (see Figure 1). Additional adjustments to the gate valves later dropped radon levels to 4.1 pCu/L.

Table 1 shows average temperature and humidity levels after the final adjustments were made to all systems. The homeowners were pleased to learn that conditions in their crawl spaces are now better than those in many homes in Nashville! Table 2 and Figure 1 show how the adjustments to the radon mitigation system and the Radostat reduced concentration.
